# Critique of the Environmental Impact Study: Moncubo Wind Farm Project

## Summary

This document presents a critical analysis of the Environmental Impact Study (EIS) for the proposed Moncubo wind farm project. The project site is situated on 9.5 square kilometers of upland limestone karst, a complex and vulnerable ecosystem. Our analysis reveals significant shortcomings in the assessment's consideration of the three-dimensional karst environment, particularly its underground network of fissures, caves, and water systems. We argue that the proposed location is fundamentally unsuitable for wind farm development due to the irreparable damage that would be inflicted on this delicate Cantabrian karst ecosystem.

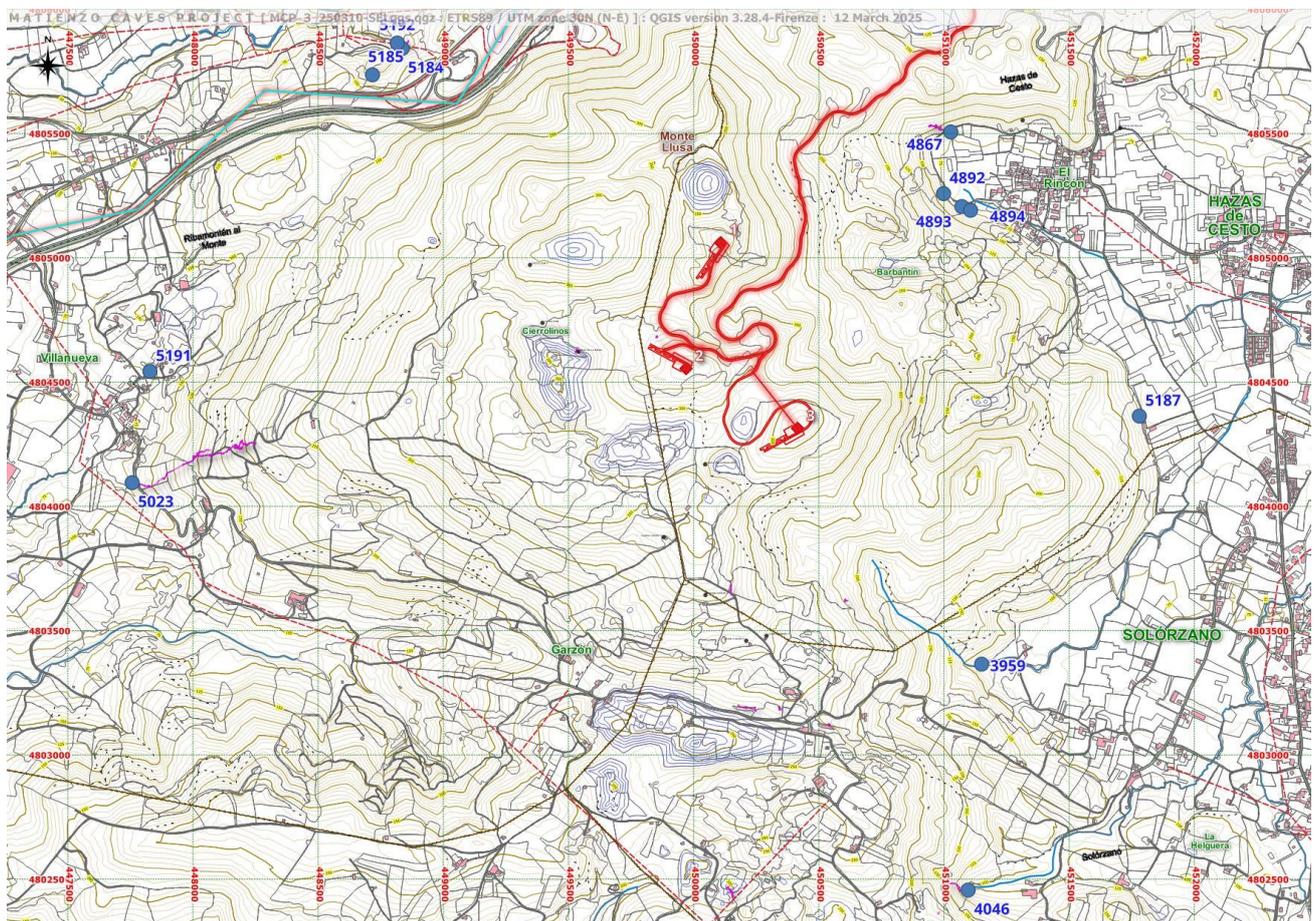
Figure 1 500m grid. **Springs at risk.** Note the cave passage extent (purple line) at Villanueva (#5023)

Several springs documented by the Matienzo Caves Project (see page 13) are located around the Monte Llusa hillsides and to the south:

- Fuente de Villanueva (#5023), Villanueva, Ribamontán al Monte
- Water source (#5191), Villanueva, Ribamontán al Monte
- Fuente del Real (#4893), El Rincón, Hazas de Cesto
- Resurgence (#4894), El Rincón, Hazas de Cesto
- Wet weather spring (#4892), El Rincón, Hazas de Cesto
- Wet weather spring (#4867), El Rincón, Hazas de Cesto
- Wet weather spring (#5187), Hazas de Cesto
- Resurgence (#3959), Solórzano
- Cueva del Arroyo de Canastrillas (#4046), Solórzano
- "Bombeo de Anero", public water supply (#5184), Ribamontán al Monte
- Flood resurgence (#5192), Ribamontán al Monte
- Resurgence (#5185), Ribamontán al Monte

These springs require comprehensive monitoring for flow changes and pollution throughout all phases of the wind farm's lifecycle, yet the EIS lacks adequate provisions for such monitoring. Details of these springs are shown in annex 1, and positions on the map are shown on figure 1, below.

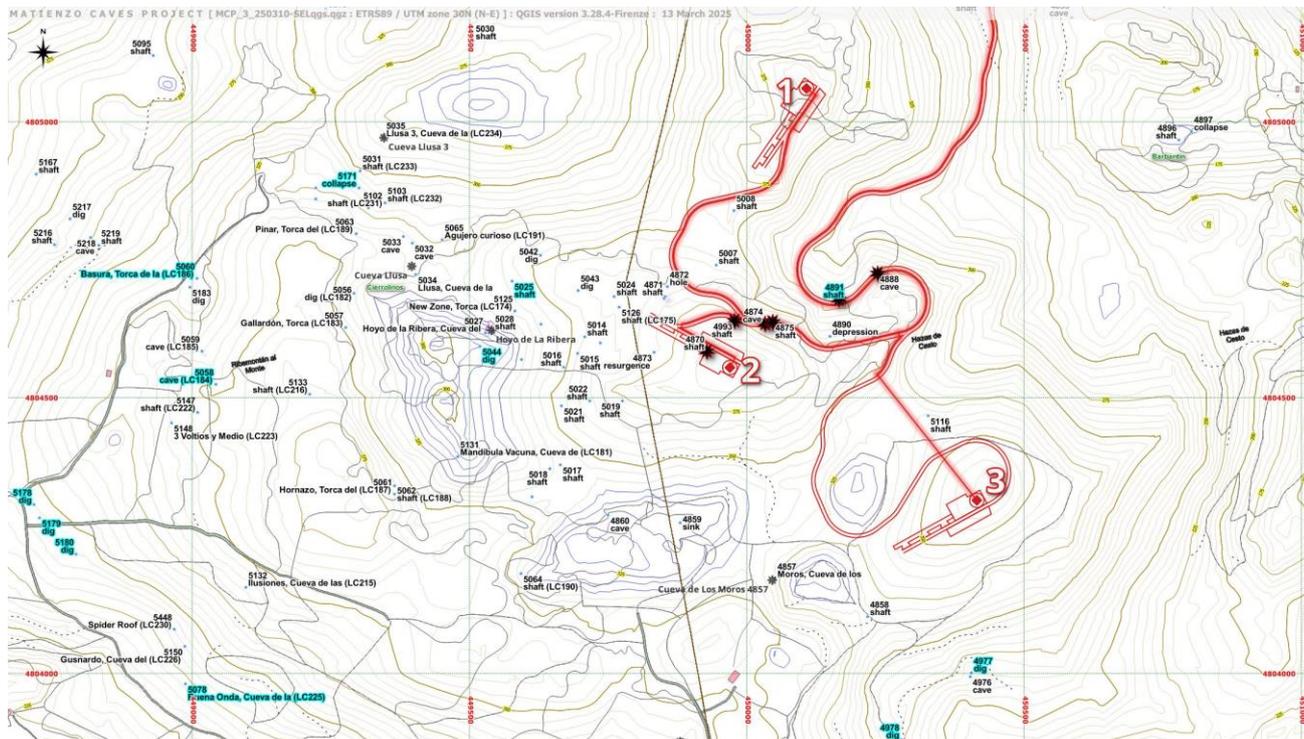
Figure 2 500m grid. Six features due to be destroyed by Alternative 1. Platform 2 is apparently being built over a pond and a wide and deep shaft.

The platform and generator 2 are placed directly over a fenced pond and a fenced deep and wide shaft (#4870). Has this point actually been visited by the proposer, or is the shapefile mapping wrong?

In addition, a number of caves and shafts will be destroyed as new roads for Alternative 1 are built. These "at risk" sites are shown on Figure 2, below.

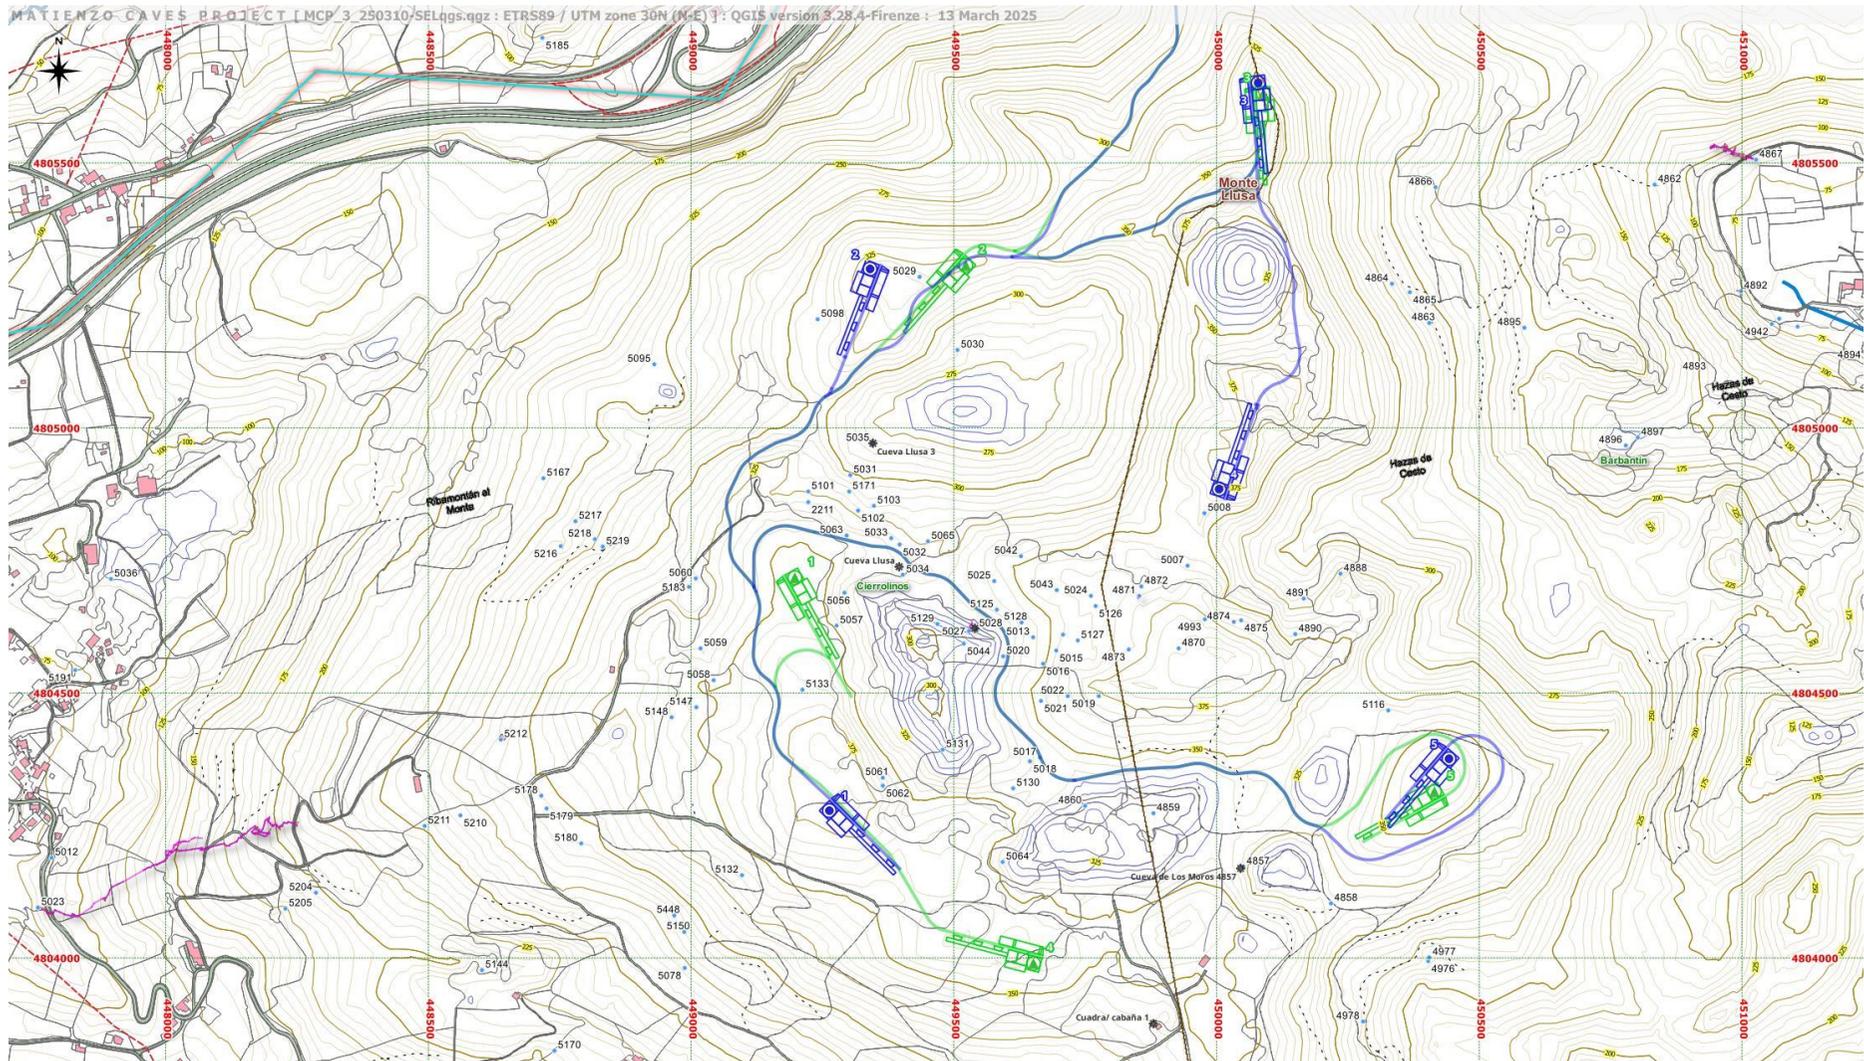
### Annex 3 – Map showing Alternatives 2 (blue) and 3 (green)

## Annex 2 - List of affected Karst features (caves, shafts, resurgences) due to Alternatives 2 and 3
